INDOOR AIR QUALITY ASSESSMENT

**Burncoat High School
179 Burncoat Street
Worcester, MA**

Prepared by:
Massachusetts Department of Public Health
Bureau of Environmental Health
Indoor Air Quality Program
March 2017

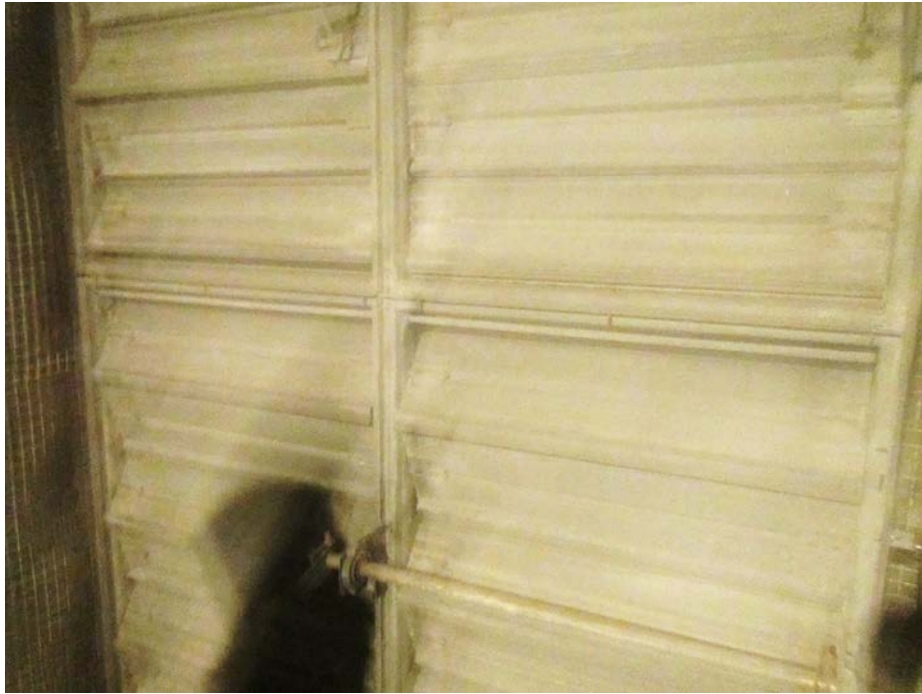
Picture 1

BEH/IAQ staff noted that the louvers for the fresh air intake vent in the mixing room were mostly closed (Picture 1). BHS facilities staff reported that this restricted setting was due to the extreme cold weather that was experienced the week prior to the assessment. Closing the fresh air louvers is the likely cause of the elevated carbon dioxide levels measured in classrooms with moderate occupancy (Table 2). Adequate fresh air supply and properly functioning exhaust are both extremely important in diluting and removing normally occurring indoor air pollutants.

Fresh air supply intake vent (note louvers nearly closed)

1. Inspect the condition of window sealant on a quarterly basis and make repairs as needed.
2. Consult a ventilation engineer to ensure proper settings for the fresh air intake louvers in the AHU mixing room. Adequate fresh air supply is vital to diluting normally occurring indoor air quality pollutants.

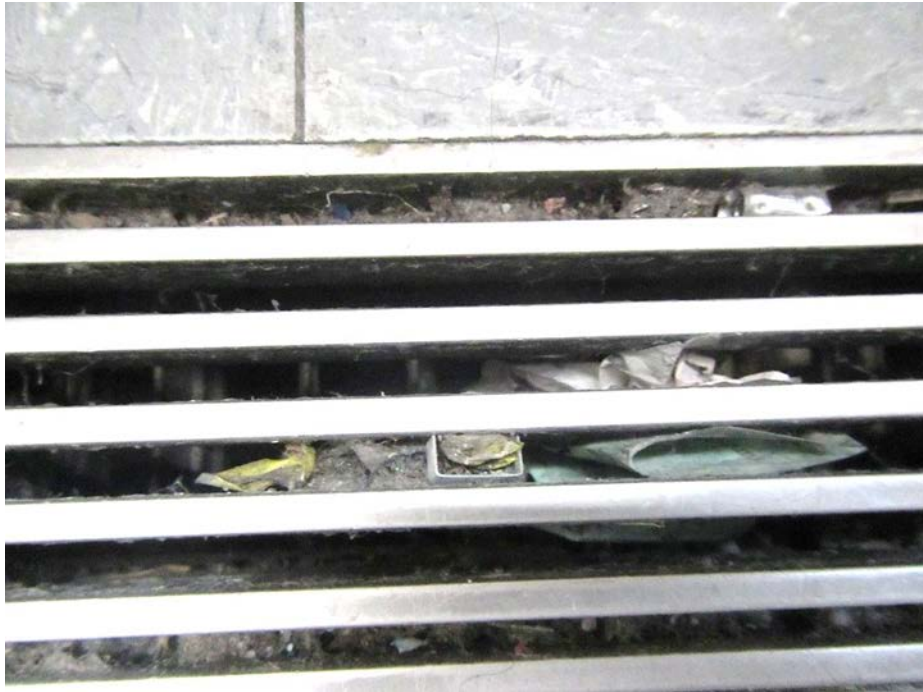
Picture 5

Floor-mounted supply and return vents were found to have accumulated debris in many areas (Picture 5). This design is prone to collect debris and may act to aerosolize particulate matter if not regularly vacuumed, preferably using a high efficiency particulate arrestance (HEPA) filter equipped vacuum cleaner.

Floor-mounted supply vent showing accumulated debris

10. Use a HEPA vacuum to regularly clean floor-mounted supply and return vents which are prone to debris accumulation.
11. Automotive exhaust systems should be utilized whenever vehicles enter the garage or when any solvents or other products containing VOCs are used in this area. Continue to refrain from idling vehicles in the building.

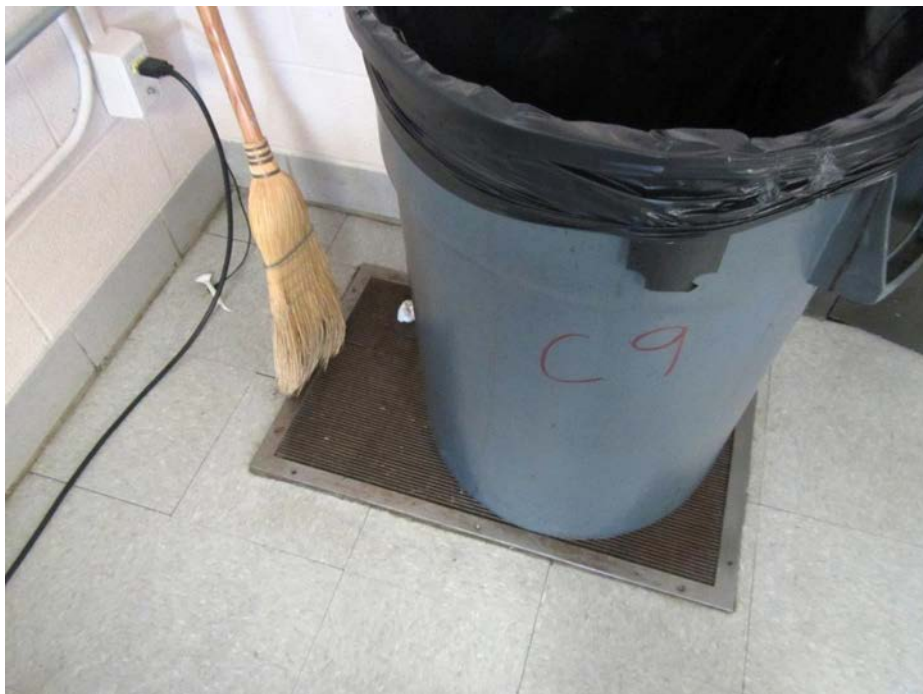
Picture 6

The location of the return vents on the floors makes it easy for the vents to be blocked by stored materials. In a number of classrooms, these vents were blocked with trash barrels (Picture 6). In order to function properly, both supply and return vents must remain free of obstructions.

Barrel and broom stored on return vent

7. Evaluate music/practice rooms for proper heating/insulation.
8. Remove all items (e.g., barrels) blocking supply and exhaust vents to ensure adequate airflow.

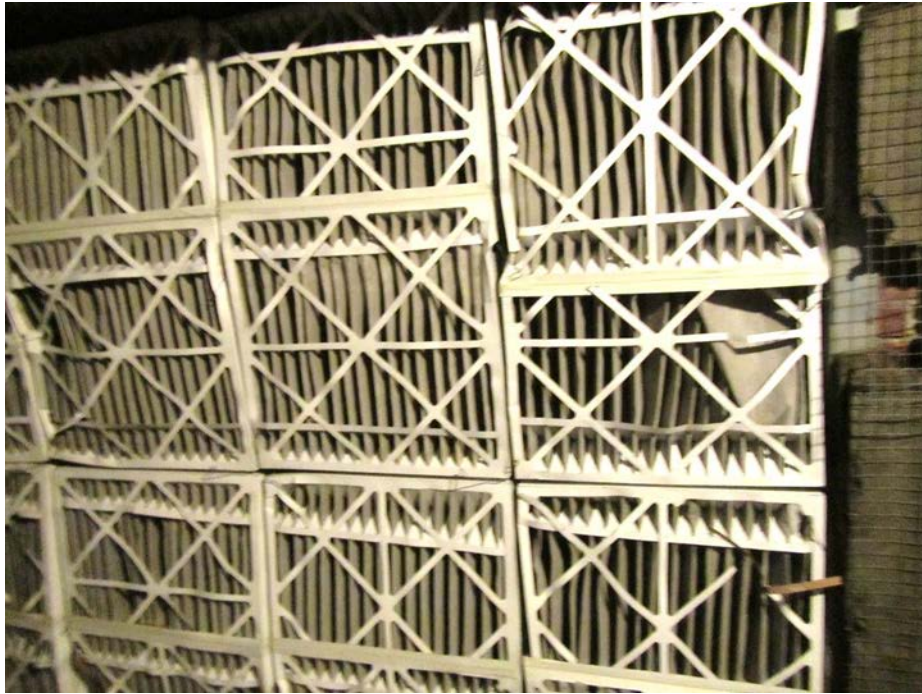
Picture 7

BHS facilities personnel reported that the filters in the mixing room are changed twice per year. BEH/IAQ staff noted that the filters appeared partially occluded at the time of assessment (Picture 7). Filter changing frequency should be increased as needed following regular inspections.

Bank of air filters in the AHU mixing room

9. Monitor AHU filters in the mixing room regularly and replace more frequently as needed. Ensure that the filters have a minimum efficiency of MERV 8 as reported by BHS staff.

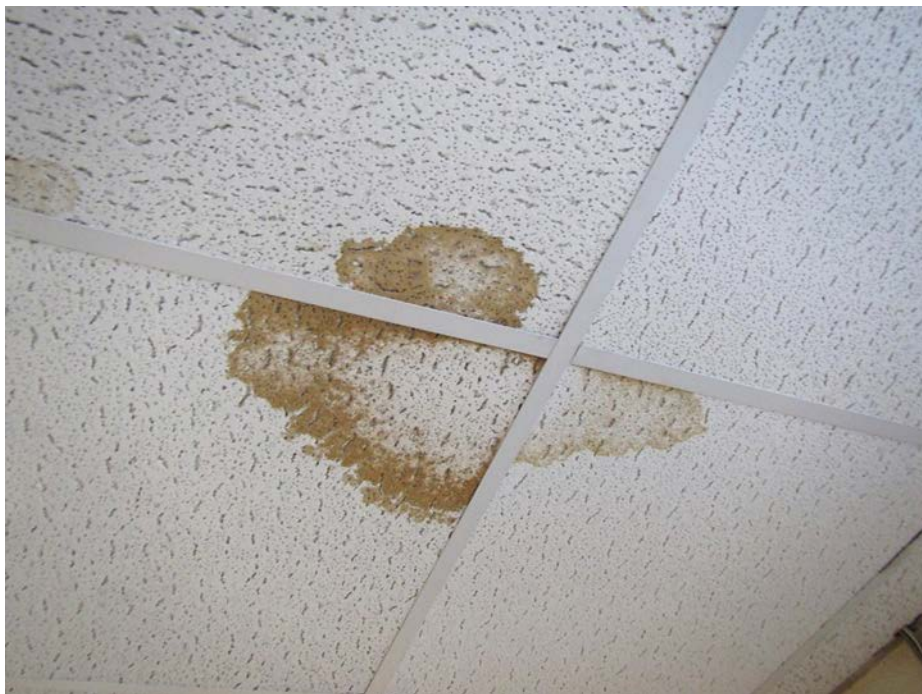
Picture 10

Water-damaged ceiling tiles were observed in several areas throughout the BHS (Table 2; Pictures 10 and 11). At the time of assessment, BHS Facilities staff indicated that water-damaged ceiling tiles are replaced routinely throughout the school. It was not clear how many of these water-damaged ceiling tiles are actively leaking or if they are due to historic leaks that have since been repaired.

Water-damaged ceiling tiles

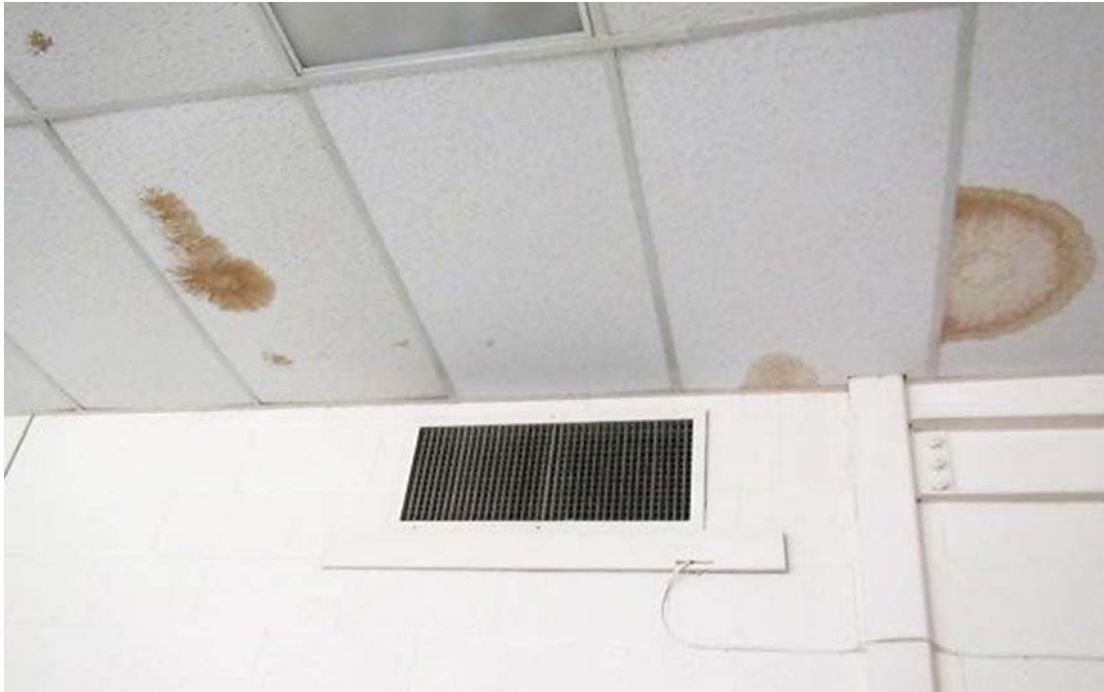
Picture 11

Water-damaged ceiling tiles

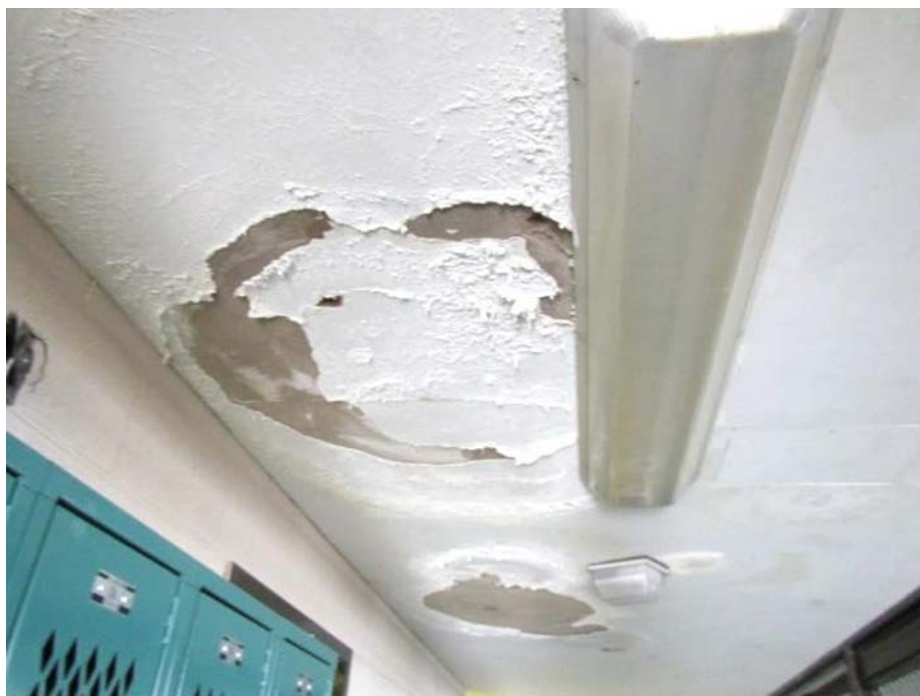
Picture 12

Water-damaged plaster ceilings were noted in some areas including the auditorium and locker rooms. It is important to note that plaster is unlikely to support mold growth even when exposed to periodic water leaks. BEH/IAQ staff did note accumulations of powdery, white material on ceilings in locker rooms (Pictures 12 and 13). The white material is called efflorescence; efflorescence is a characteristic sign of water damage to building materials such as brick, mortar, or plaster, but it is not mold growth. As moisture penetrates and works its way through mortar around brick, water-soluble compounds dissolve, creating a solution. As the solution moves to the surface of the brick or mortar, water evaporates, leaving behind white, powdery mineral deposits. This condition indicates that water from the exterior has penetrated into the building. Plaster and brick do not typically support mold growth because these materials

Water-damaged plaster ceilings in Men's Locker room

4. Ensure that any water-damaged plaster ceilings/walls are repaired and clean any associated debris (e.g., auditorium) to avoid irritant effects.
5. Determine whether abandoned plumbing fixtures are to be used or not. Fixtures that are to be used should have water poured into drains on a regular basis to avoid dry drain traps. Fixtures no longer needed should be removed and properly capped.

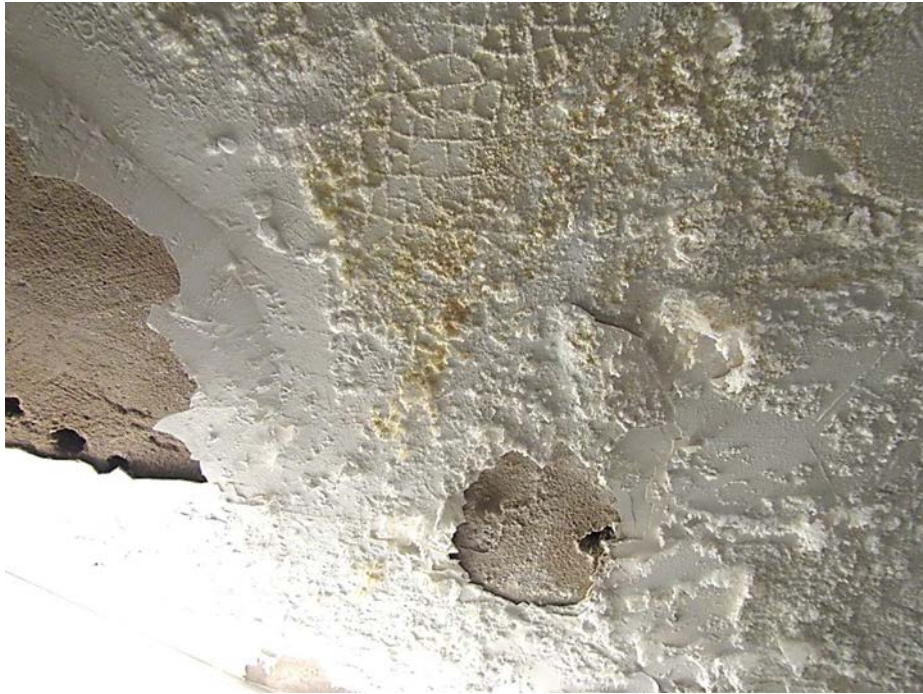
Picture 13

are not carbon-based; however paint, items, or debris near the walls that are moistened may become mold-colonized. When present, efflorescence can be readily cleaned. BHS Facilities staff indicated that the leaks in the auditorium are ongoing and are currently being addressed by roofers. Locker room water damage was extensive and it was reported by BHS Facilities staff that the women's locker room has been closed until planned renovations to the area are made.

Water-damaged plaster ceiling in Women's Locker room (note efflorescence)

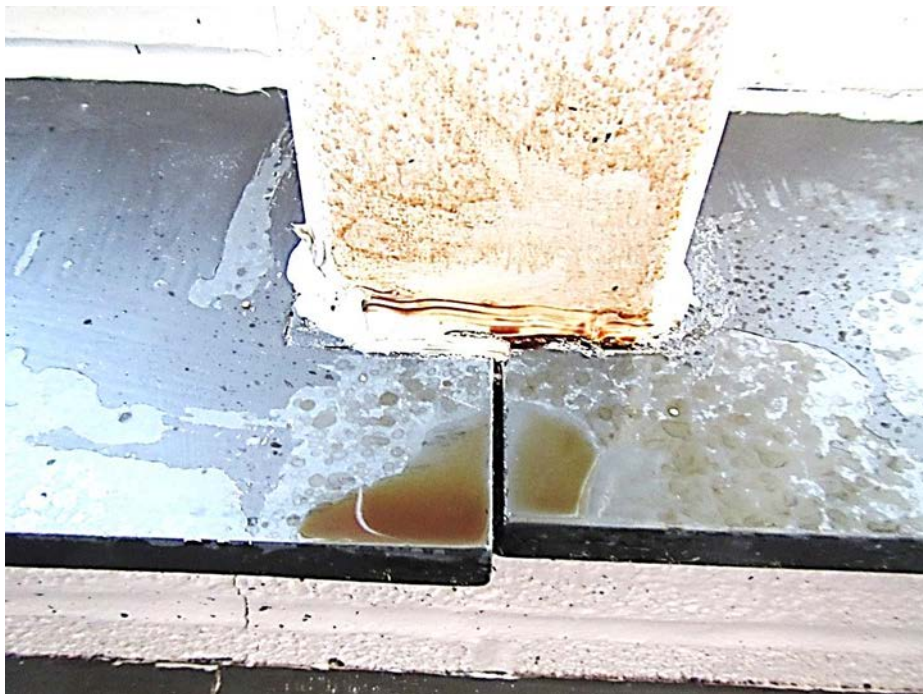
Picture 14

BEH/IAQ staff noted a classroom with an active water leak around a column in room F2 (Picture 14). This leak was coming from the ceiling around the column and may be the result of a roof or flashing failure in that area. This leak should be repaired to prevent water damage to porous building materials.

Actively leaking area around column in room F2

3. Continue to ensure all water leaks (e.g., auditorium roof and column in room F2) are fixed promptly and remove any water-damaged porous materials (e.g., ceiling tiles) that were not dried properly within 24-48 hours.

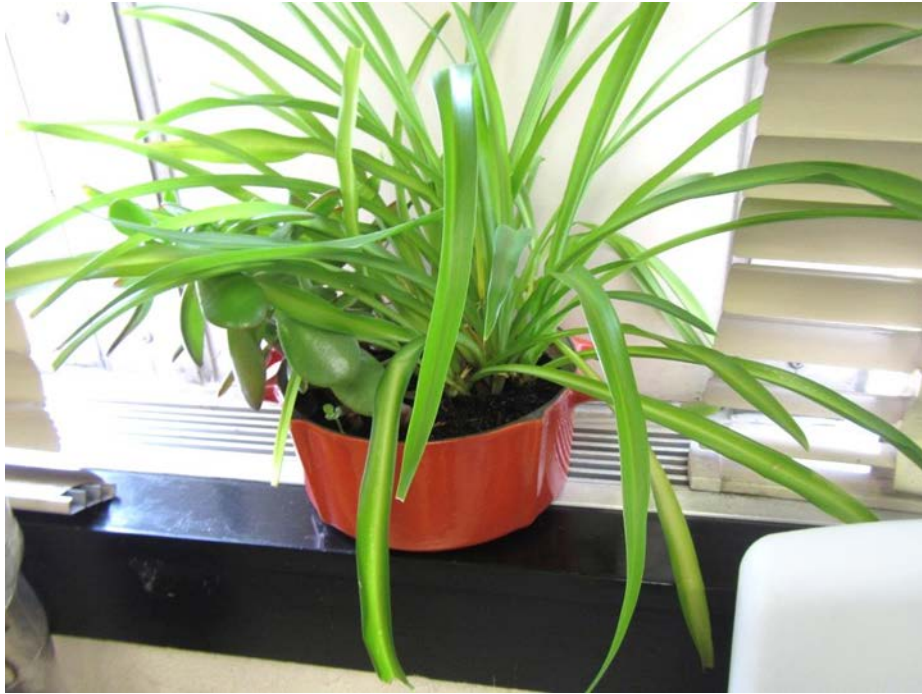
Picture 15

Several classrooms contained plants (Table 2). Plants can be a source of pollen and mold, which can be respiratory irritants to some individuals. Plants should be properly maintained and equipped with drip pans to prevent water damage to porous materials. Plants should also be located away from air diffusers to prevent the aerosolization of dirt, pollen, and mold (Picture 15).

Plant located in air stream of supply diffuser

16. Move plants away from any air streams in classrooms. Avoid over-watering or placing them on porous materials (e.g., cloth, paper) and examine drip pans periodically for mold growth.

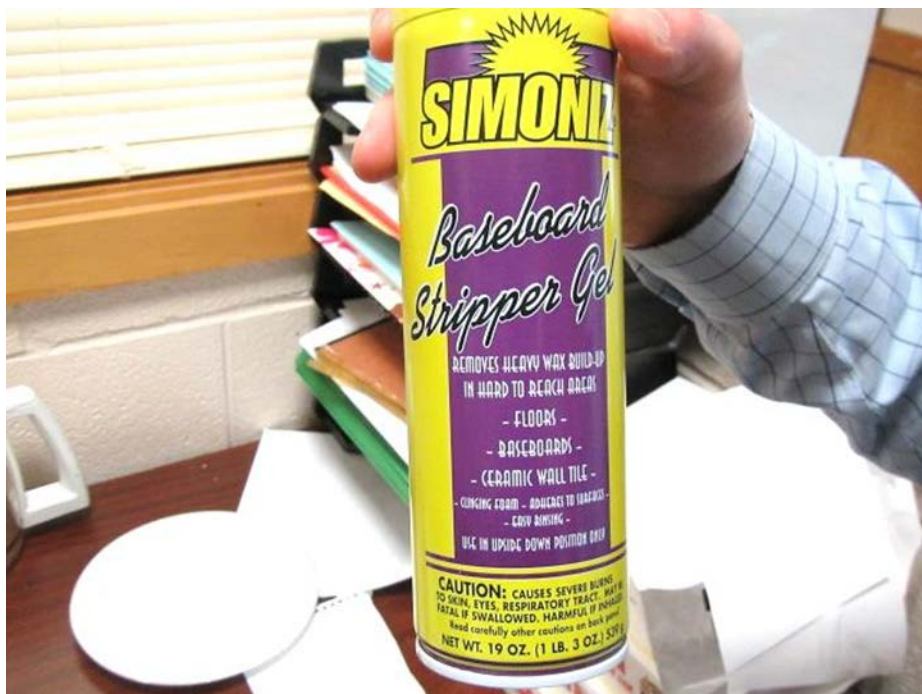
Picture 16

Other conditions that can affect IAQ were observed during the assessment. Exposure to low levels of total volatile organic compounds (TVOCs) may produce eye, nose, throat, and/or respiratory irritation in some sensitive individuals. To determine if VOCs were present, BEH/IAQ staff examined rooms for products containing VOCs. BEH/IAQ staff noted hand sanitizers, cleaners, air deodorizers, and dry erase materials in use within the building (Picture

16; Table 2). All of these products have the potential to be irritants to the eyes, nose, throat, and respiratory system of sensitive individuals.

Cleaner/floor stripper containing strong irritants

18. Eliminate the use of scented items, including air deodorizing sprays and plug-ins to prevent respiratory irritation.
19. Reduce the use of or eliminate products containing VOC's in classrooms (harsh cleaners, hand sanitizers, etc.).

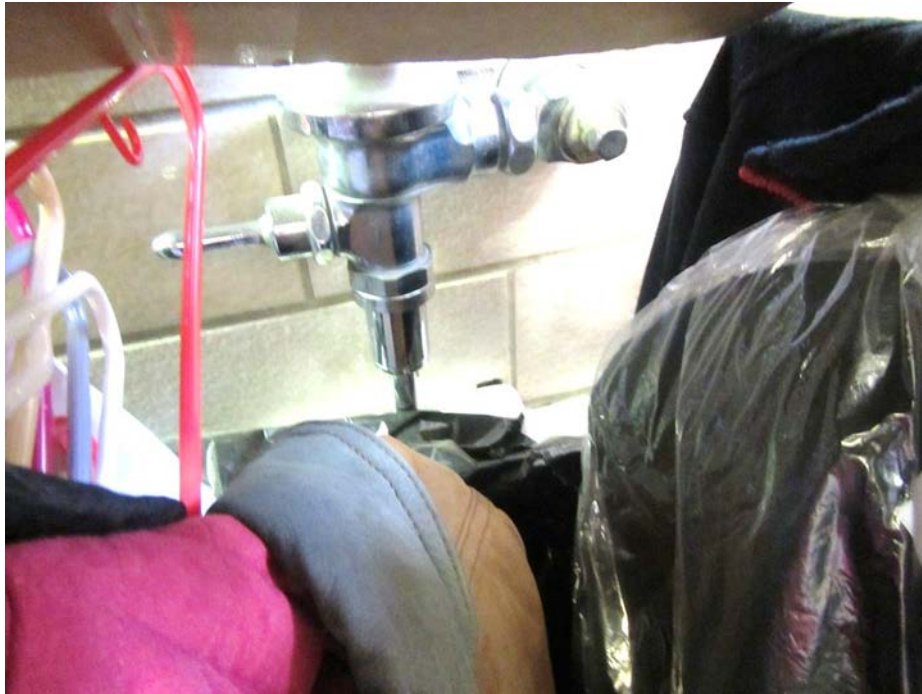
Picture 17

Abandoned plumbing fixtures were noted in several areas including the clothing “Boutique”, locker rooms, room C1B and science labs (Table 2; Pictures 17 to 19). These fixtures should be removed and properly capped if it is decided that they will not be used in the future. Otherwise water should be added regularly to the fixtures/drains to avoid dry drain traps which allow sewer gas to accumulate in occupied spaces. BHS staff reported that drains in locker rooms have a water/vinegar solution added regularly however some shower stalls have accumulated storage which may make this task difficult.

Abandoned urinal in Clothes Boutique

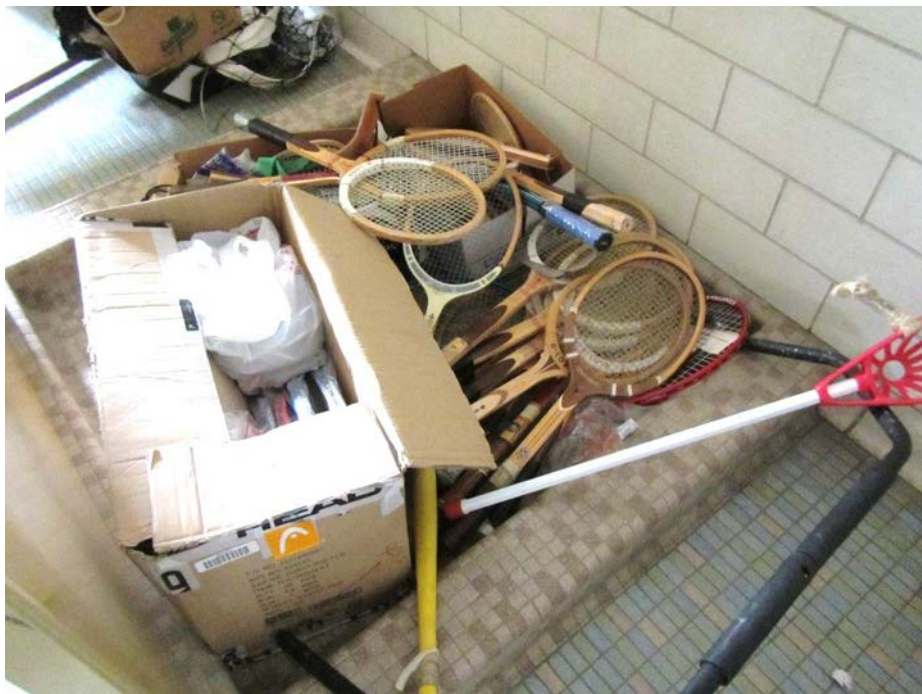
Picture 18

Abandoned shower stall in Women's Lockers (note stored items over drain)

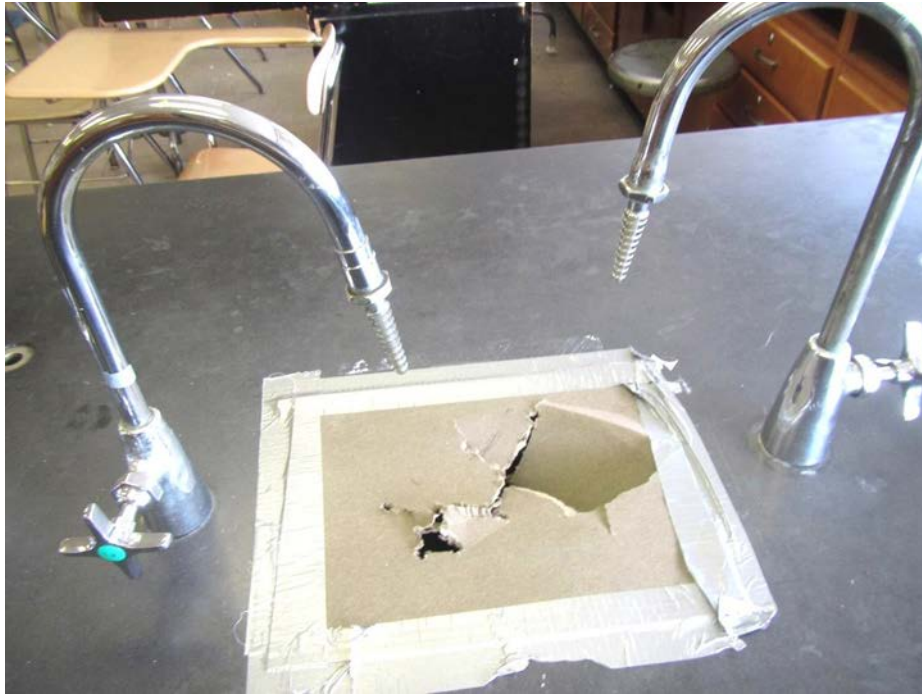
Picture 19

Abandoned sinks in science room

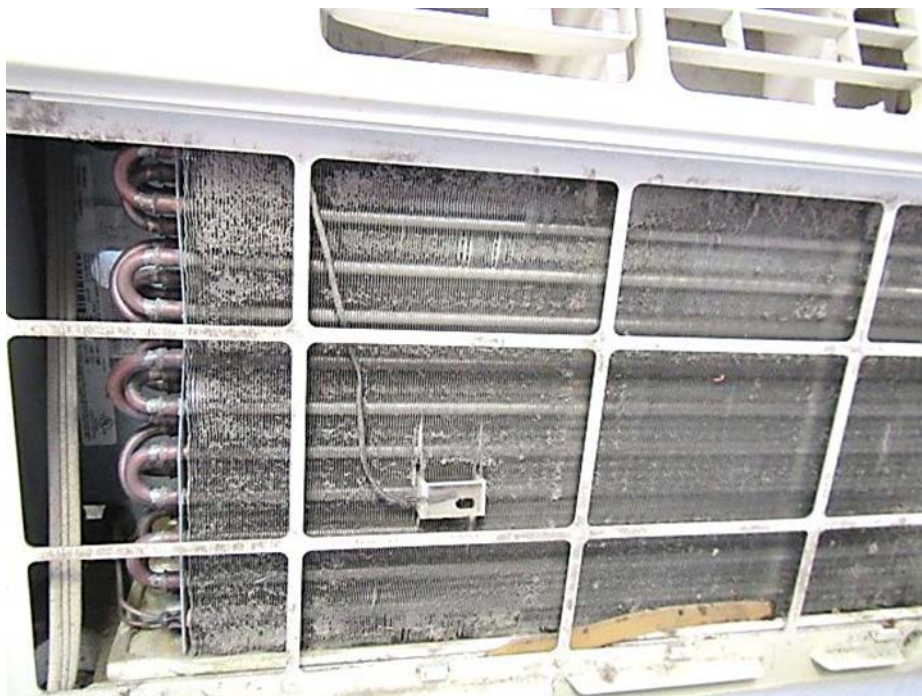
Picture 20

Window-mounted air-conditioning units were observed in some areas. This type of equipment has a filter, which should be cleaned prior to use. Any debris that accumulates in the coils of the unit should also be cleaned according to manufacturer’s recommendations (Picture 20).

Window AC unit showing debris accumulated in coils

12. Regularly clean window-mounted air conditioning filters and units according to manufacturer's recommendations. Ensure cooling fins are clean and free of debris.

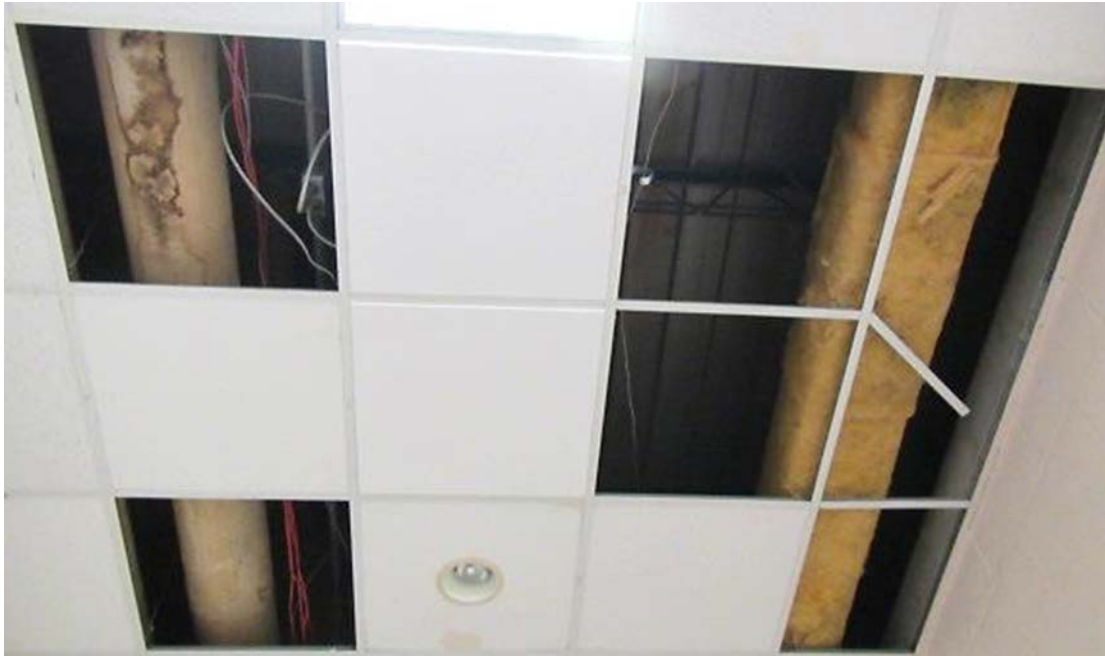
Picture 21

Missing ceiling tiles were observed in some rooms and hallways (Picture 21). Missing and ajar ceiling tiles can allow dust and debris from the ceiling plenum system to migrate into occupant spaces. All ceiling tile systems should be intact and flush.

Missing ceiling tiles in F-wing hallway, note water-damaged pipe insulation and exposed fiberglass

13. Replace missing ceiling tiles to prevent the egress of dirt, dust, and particulate matter into occupied areas.
14. Replace water-damaged pipe insulation in F-wing hallway (Picture 21).

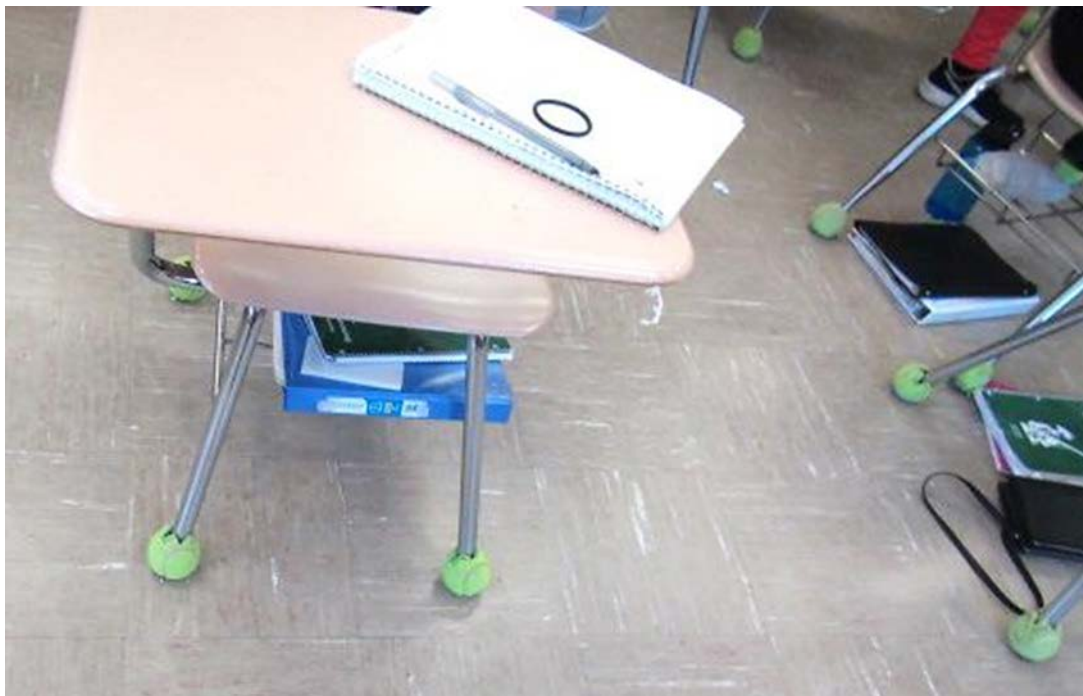
Picture 22

Tennis balls had been sliced open and placed on chair footings to reduce noise (Picture 22). Tennis balls are made of a number of materials that are a source of respiratory irritants. Constant wearing of tennis balls can produce fibers and lead to off-gassing of VOCs. Tennis balls are made with a natural rubber latex bladder, which becomes abraded when used as a chair leg pad. Use of tennis balls in this manner may introduce latex dust into the school environment. Some individuals are highly allergic to latex (e.g., spina bifida patients) (SBAA, 2001). It is recommended that the use of materials containing latex be limited in buildings to reduce the likelihood of symptoms in sensitive individuals (NIOSH, 1997; NIOSH, 1998).

Tennis balls used as chair glides

20. Clean chalk trays, dry erase board trays, and areas around pencil sharpeners to prevent accumulation of materials.
21. Replace tennis balls on chair footings with latex-free glides.

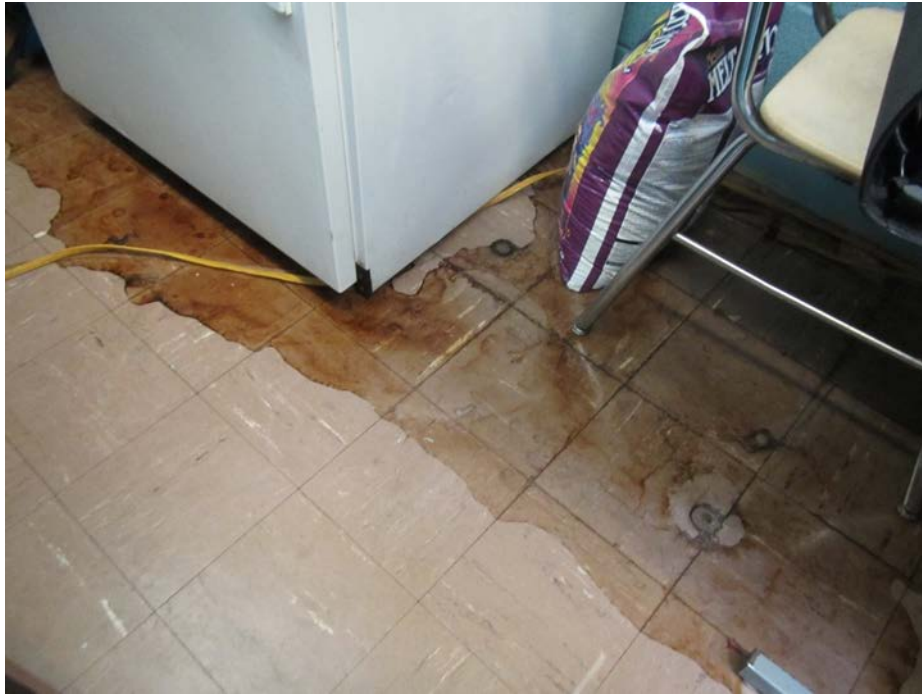
Picture 23

Large spill of possible coffee residue remaining on floor

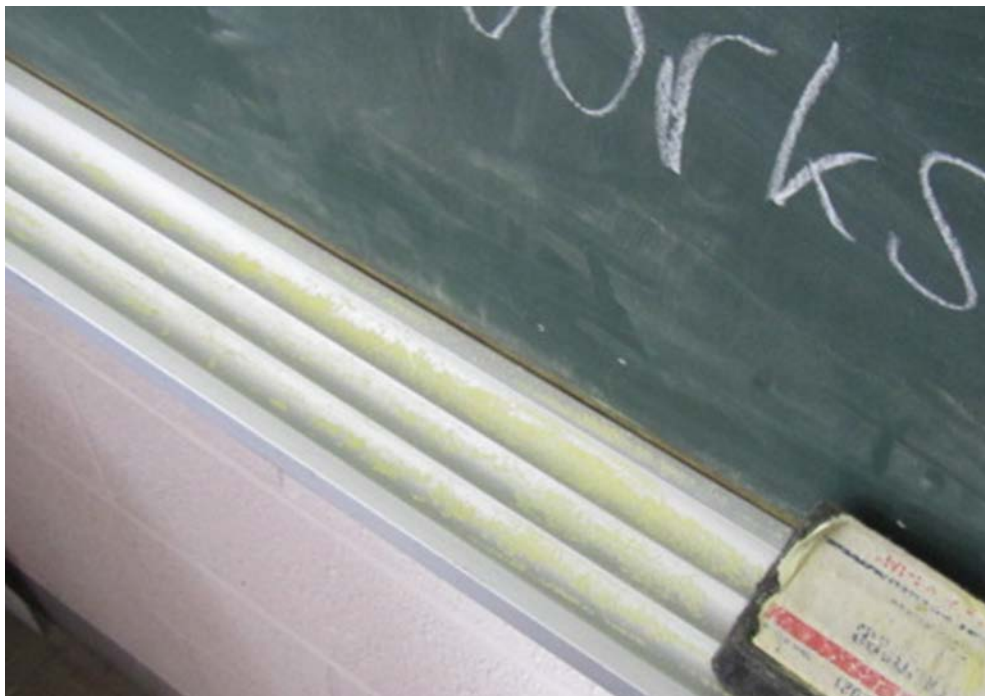
Picture 24

Many classrooms have dry erase boards and/or chalk boards. Some classrooms were noted to have accumulations of chalk dust (Picture 24) or dry erase residue in the trays. Both of these may have irritant effects when aerosolized.

Accumulation of chalk dust in the tray
